**THE PORT PERRY**  
**GRAIN**  
**ELEVATOR**

**CANADA'S OLDEST  
WOOD CRIB ELEVATOR**

## George Currie's Grain Elevator

Researched and published by J. Peter Hvidsten

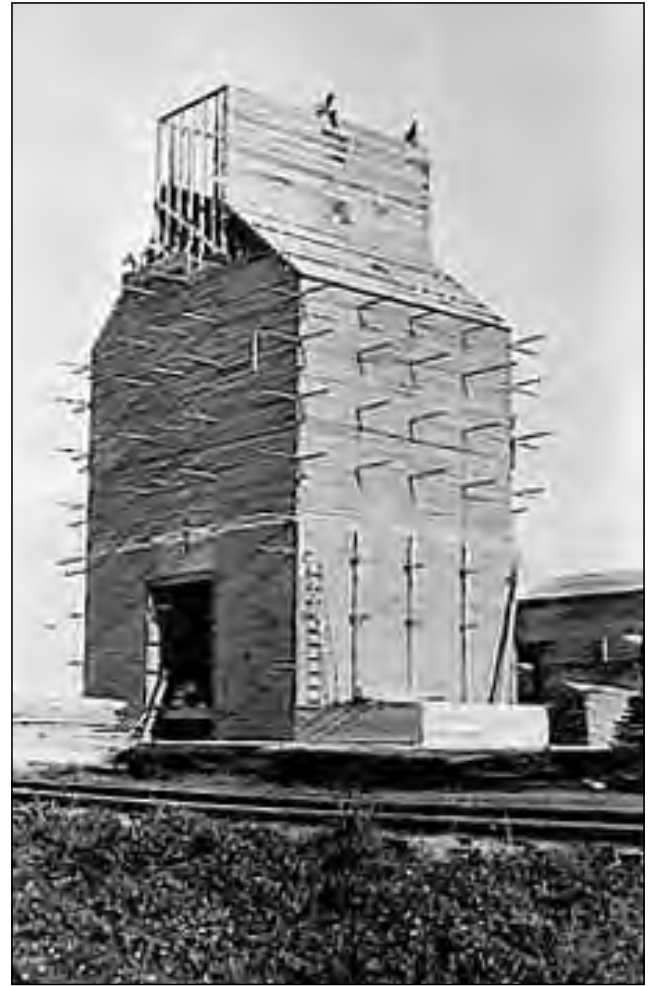
This grain elevator, under construction at Redwood County, Minnesota, in 1910, illustrates the framing of the structure.

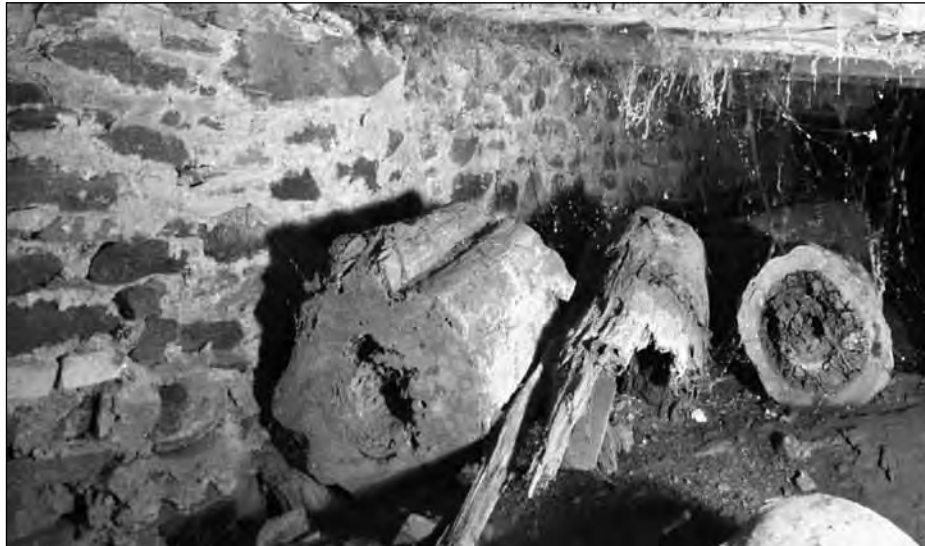
Huge wood support beams now rest on the dirt floor, beside the original stone foundation, having been replaced by concrete piers.

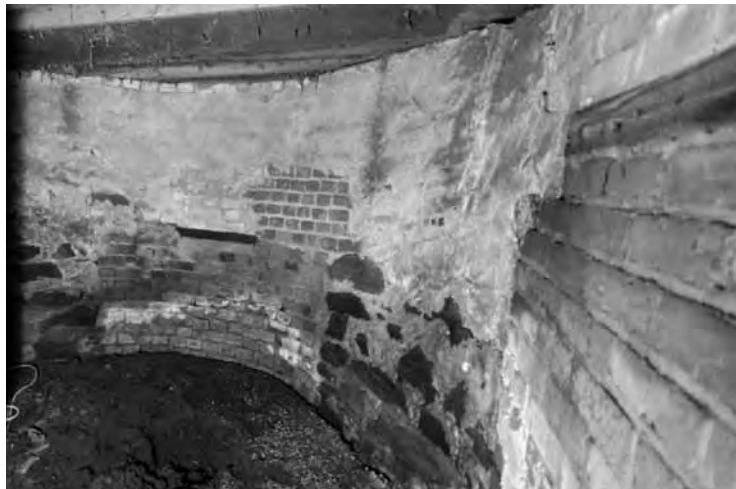
The stone foundation in the "pit" under the main floor shows there have been many repairs over the past 140 years.

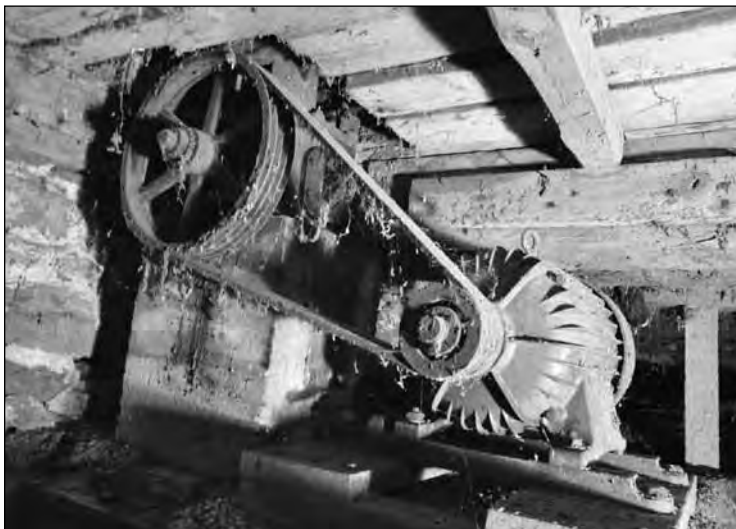
This heavy motor powered the auger which raised grain from the main floor to the turnheads in the cupola at the top of the elevator.

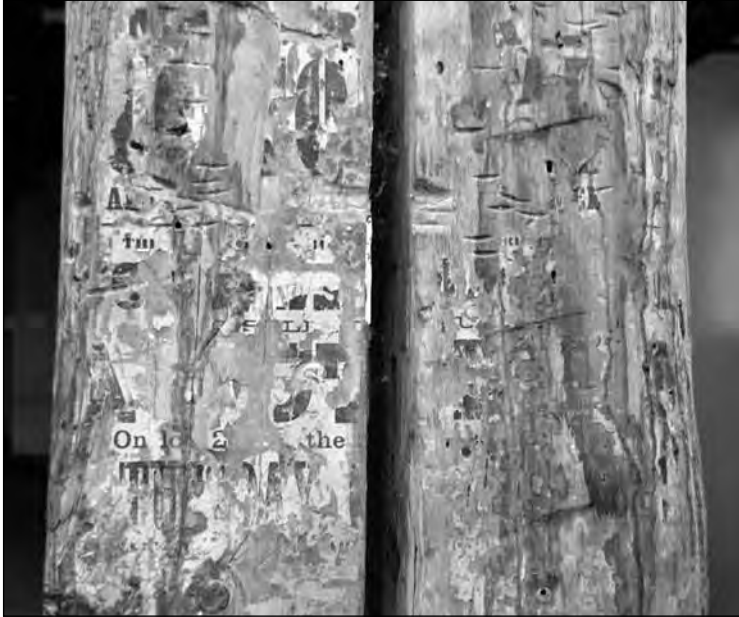
Large hand hewn posts were often assembled into groups of two or four to create one massive support column.

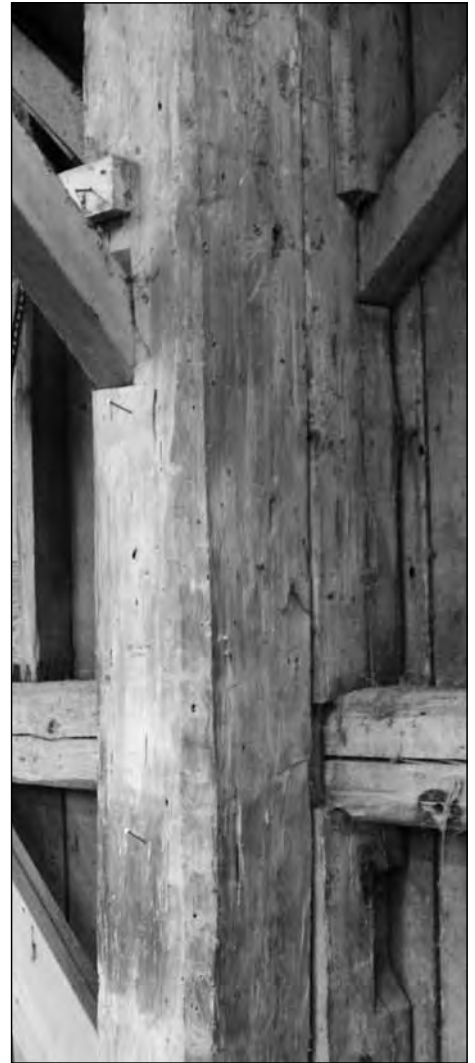
Huge posts and beams, some as large as 10"x 10" in size, helped provide the strength of the structure.

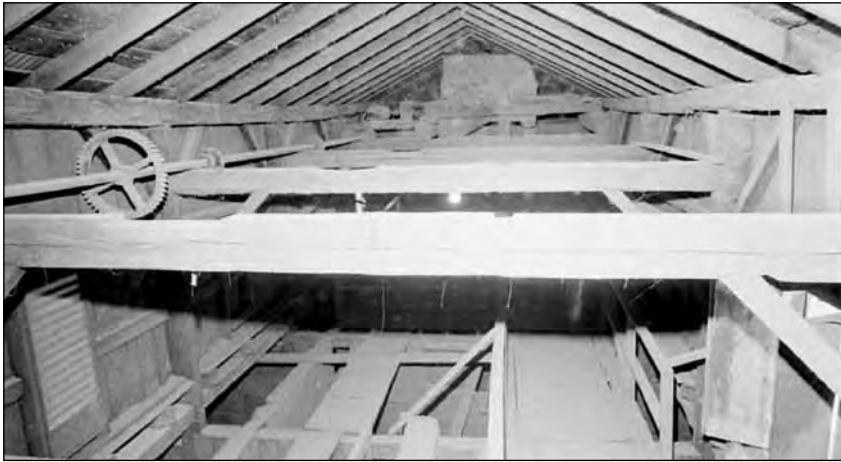
The "headhouse" or "cupola" at the top of the Port Perry elevator.

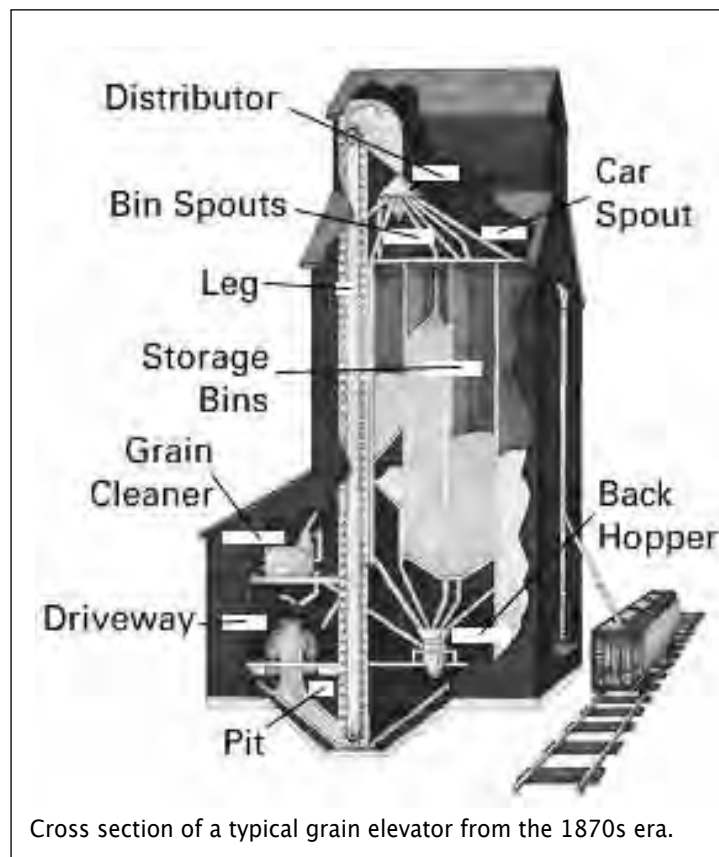
Cross section of a typical grain elevator from the 1870s era.

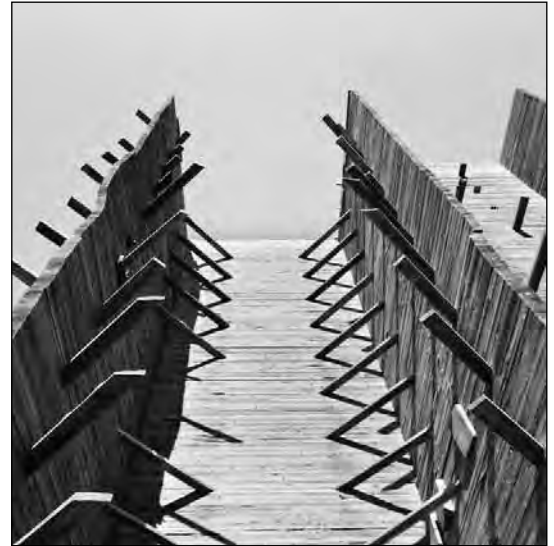
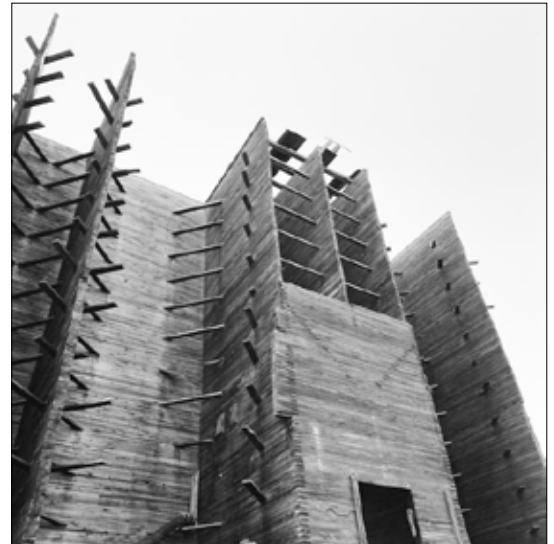
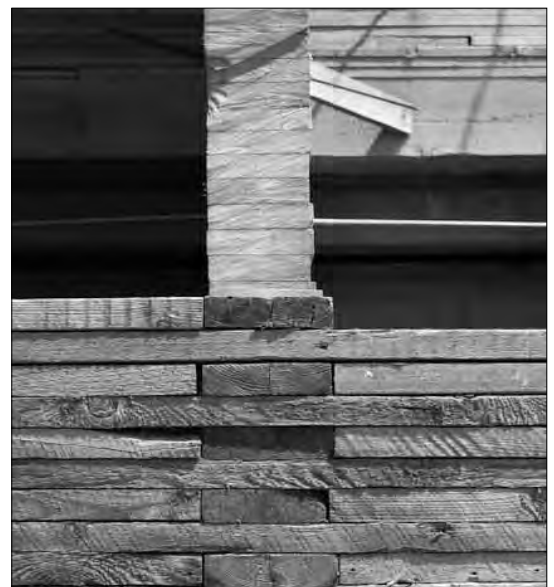
These pictures, from Pullman, Washington, USA are good examples of the construction of wood bin elevators throughout Canada and the USA in the late 1800s. The Port Perry elevator would have used similar construction methods.

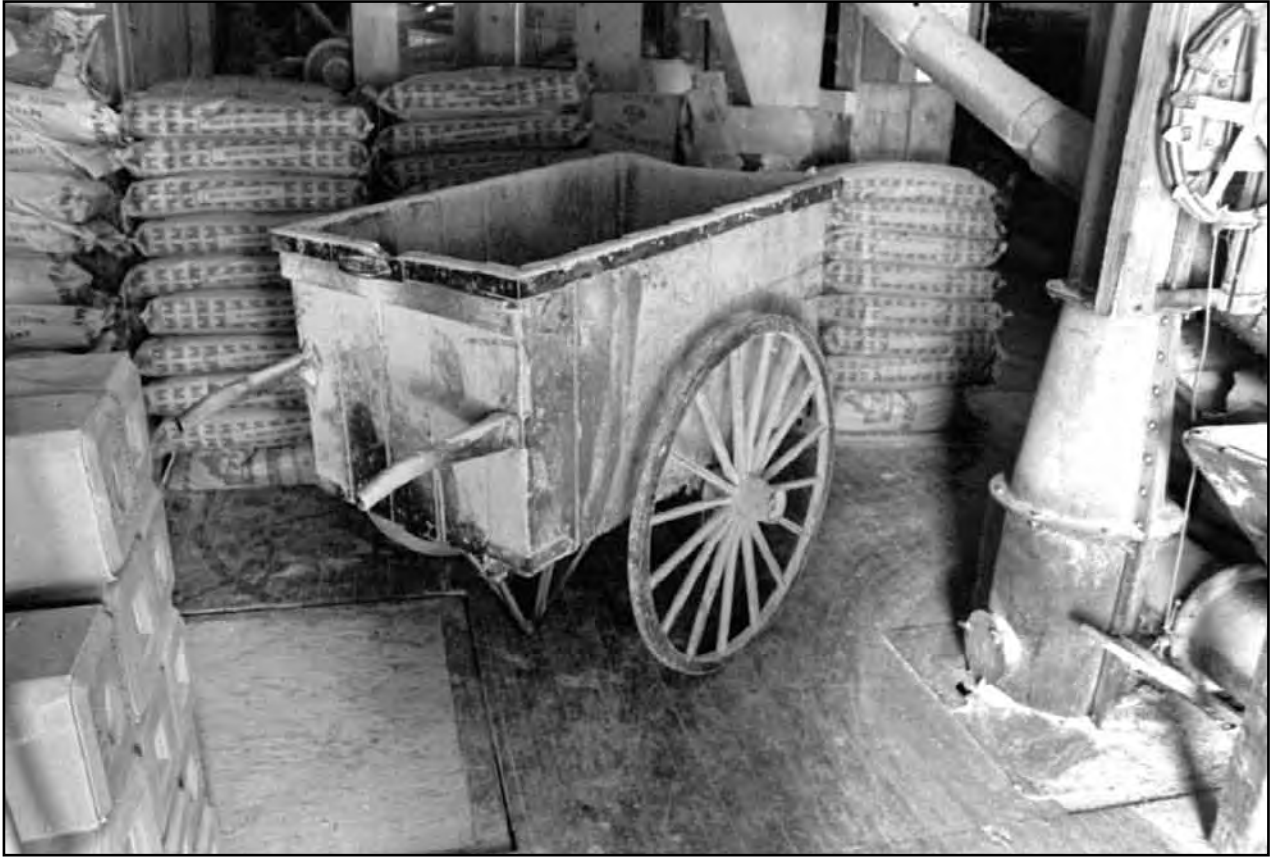
This old grain wagon was used to collect grain as it was emptied from the bins, and then weighed on a floor scale (square in the floor) before being bagged or shipped out in bulk to a customer.

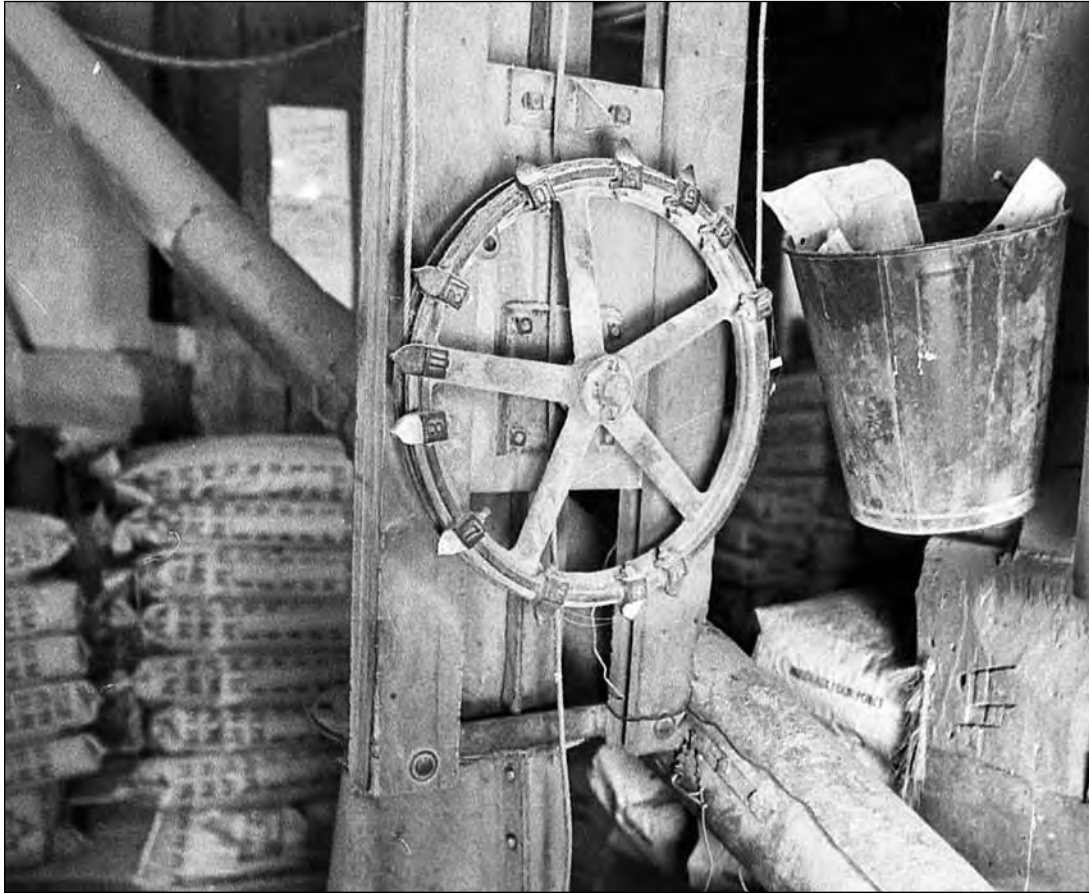
The bin selector wheel, located on the main floor of the mill.

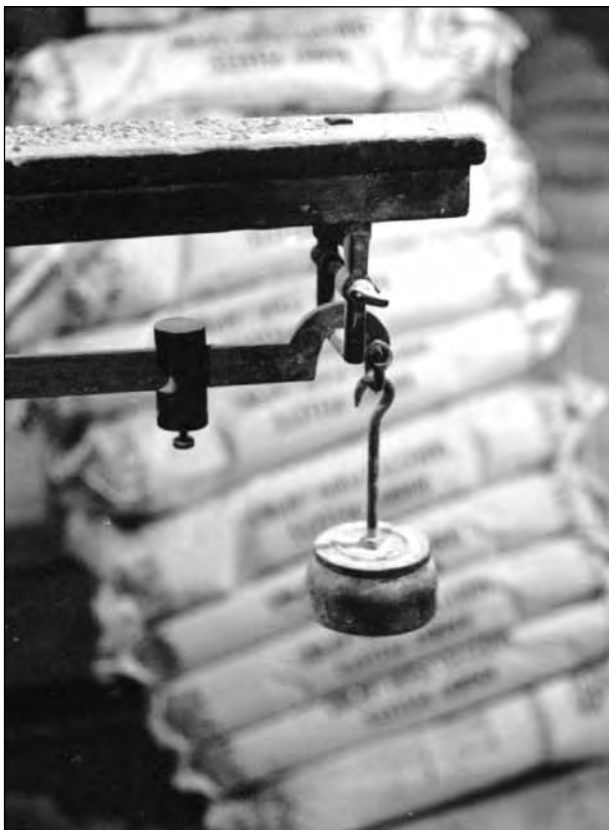
The weigh scale on the main floor.

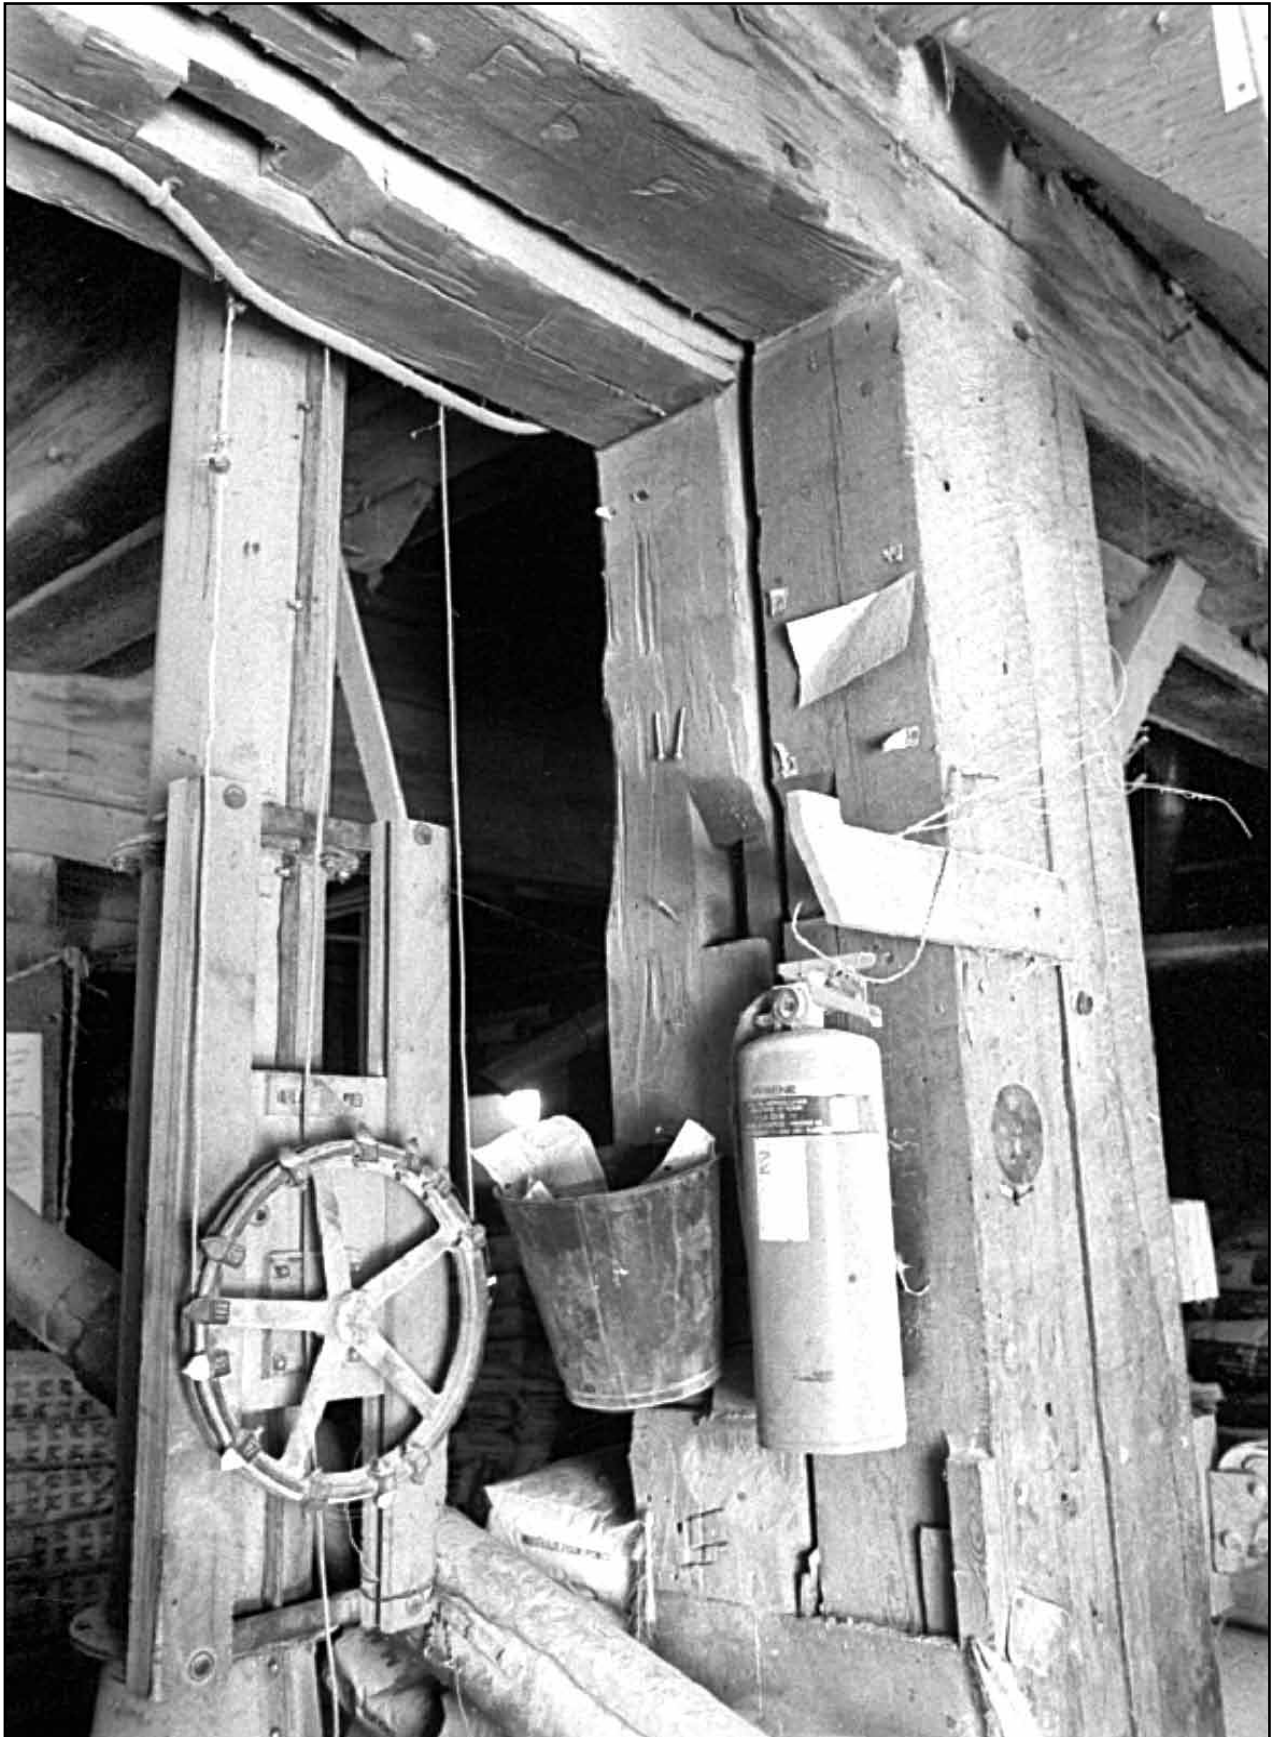
This picture shows the bin selector wheel, which was used to direct grain up to the top of the tower where it would be distributed into one of the many bins. A number on each of the cogs, which indicated the number of each bin. Note the heavy beam construction.

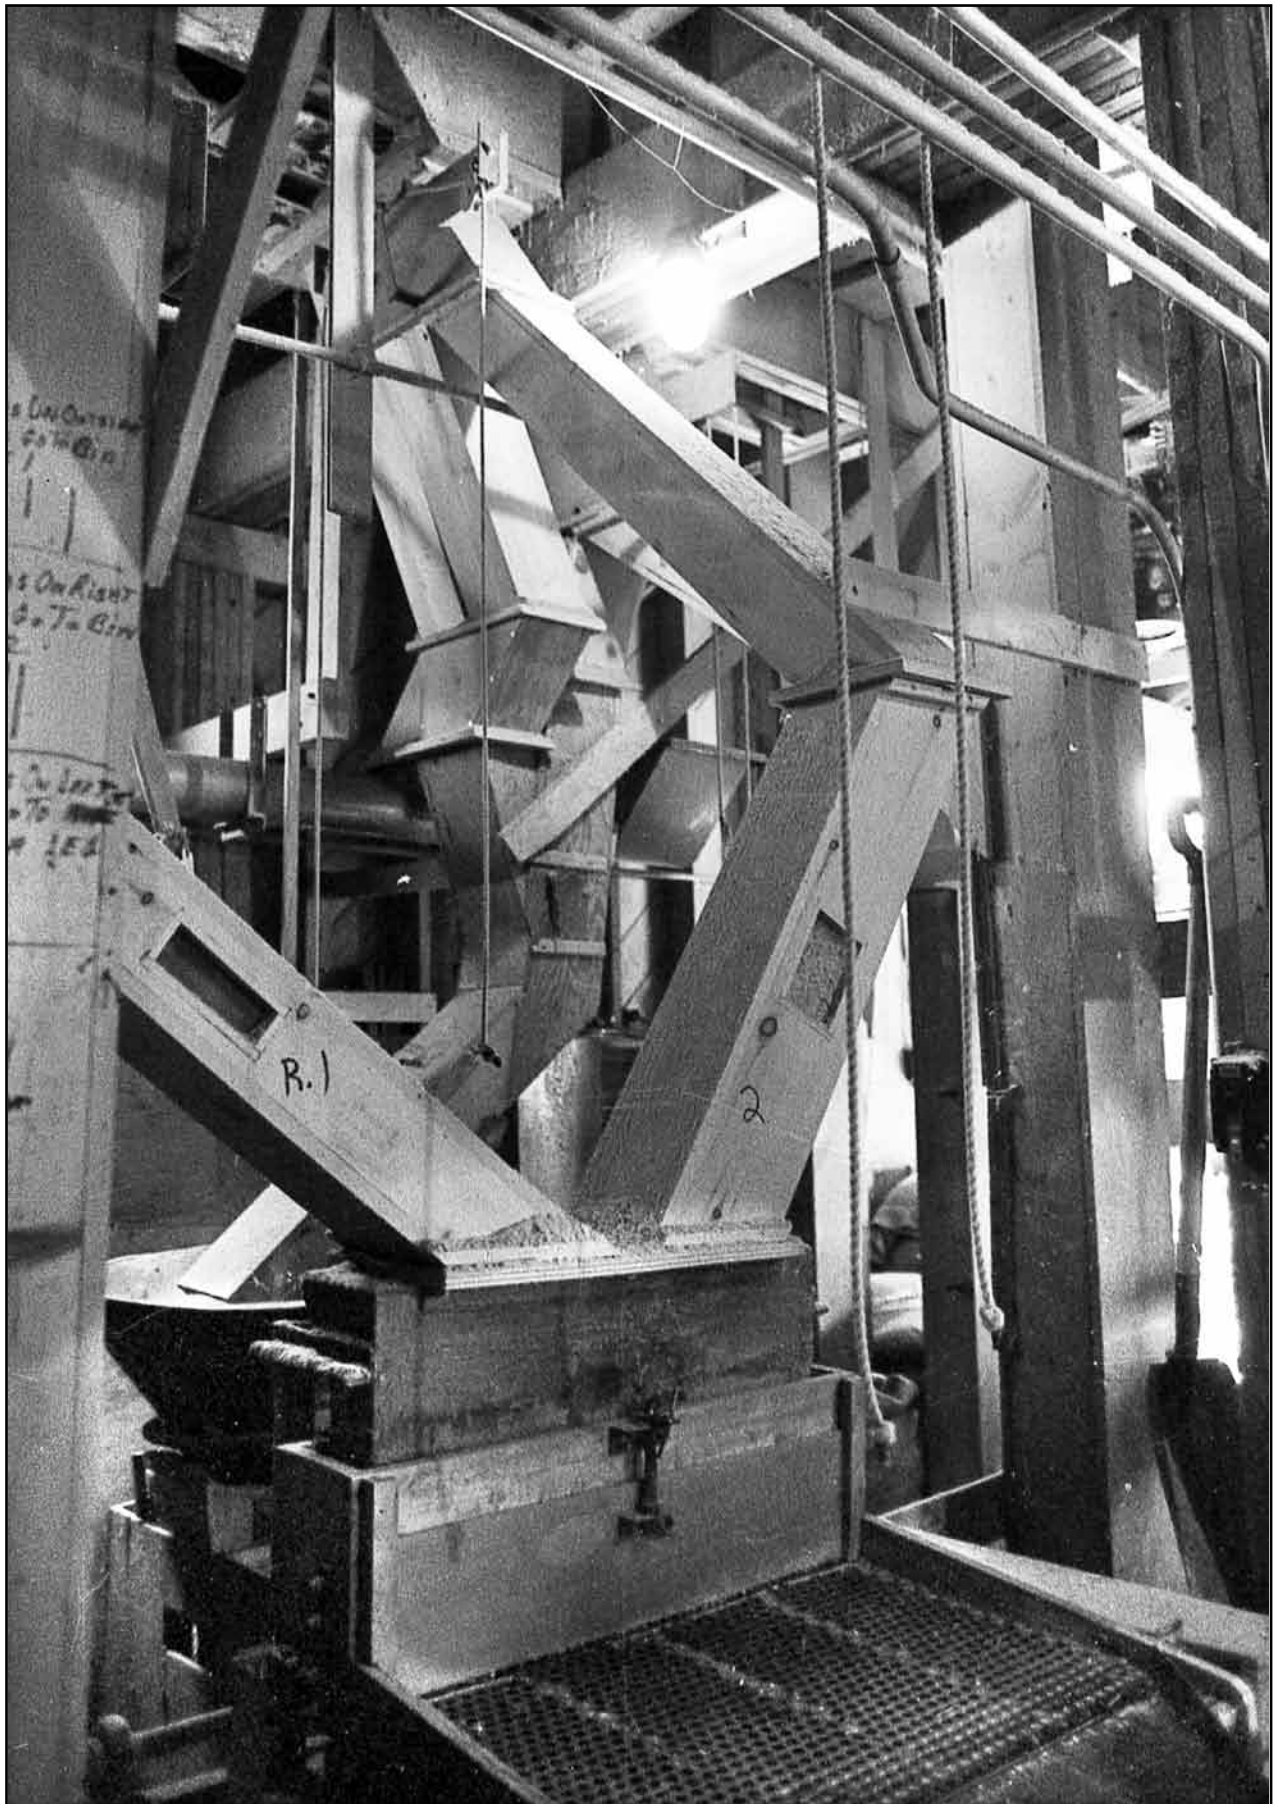
Grain cleaner at the Master Feeds mill, 1980.

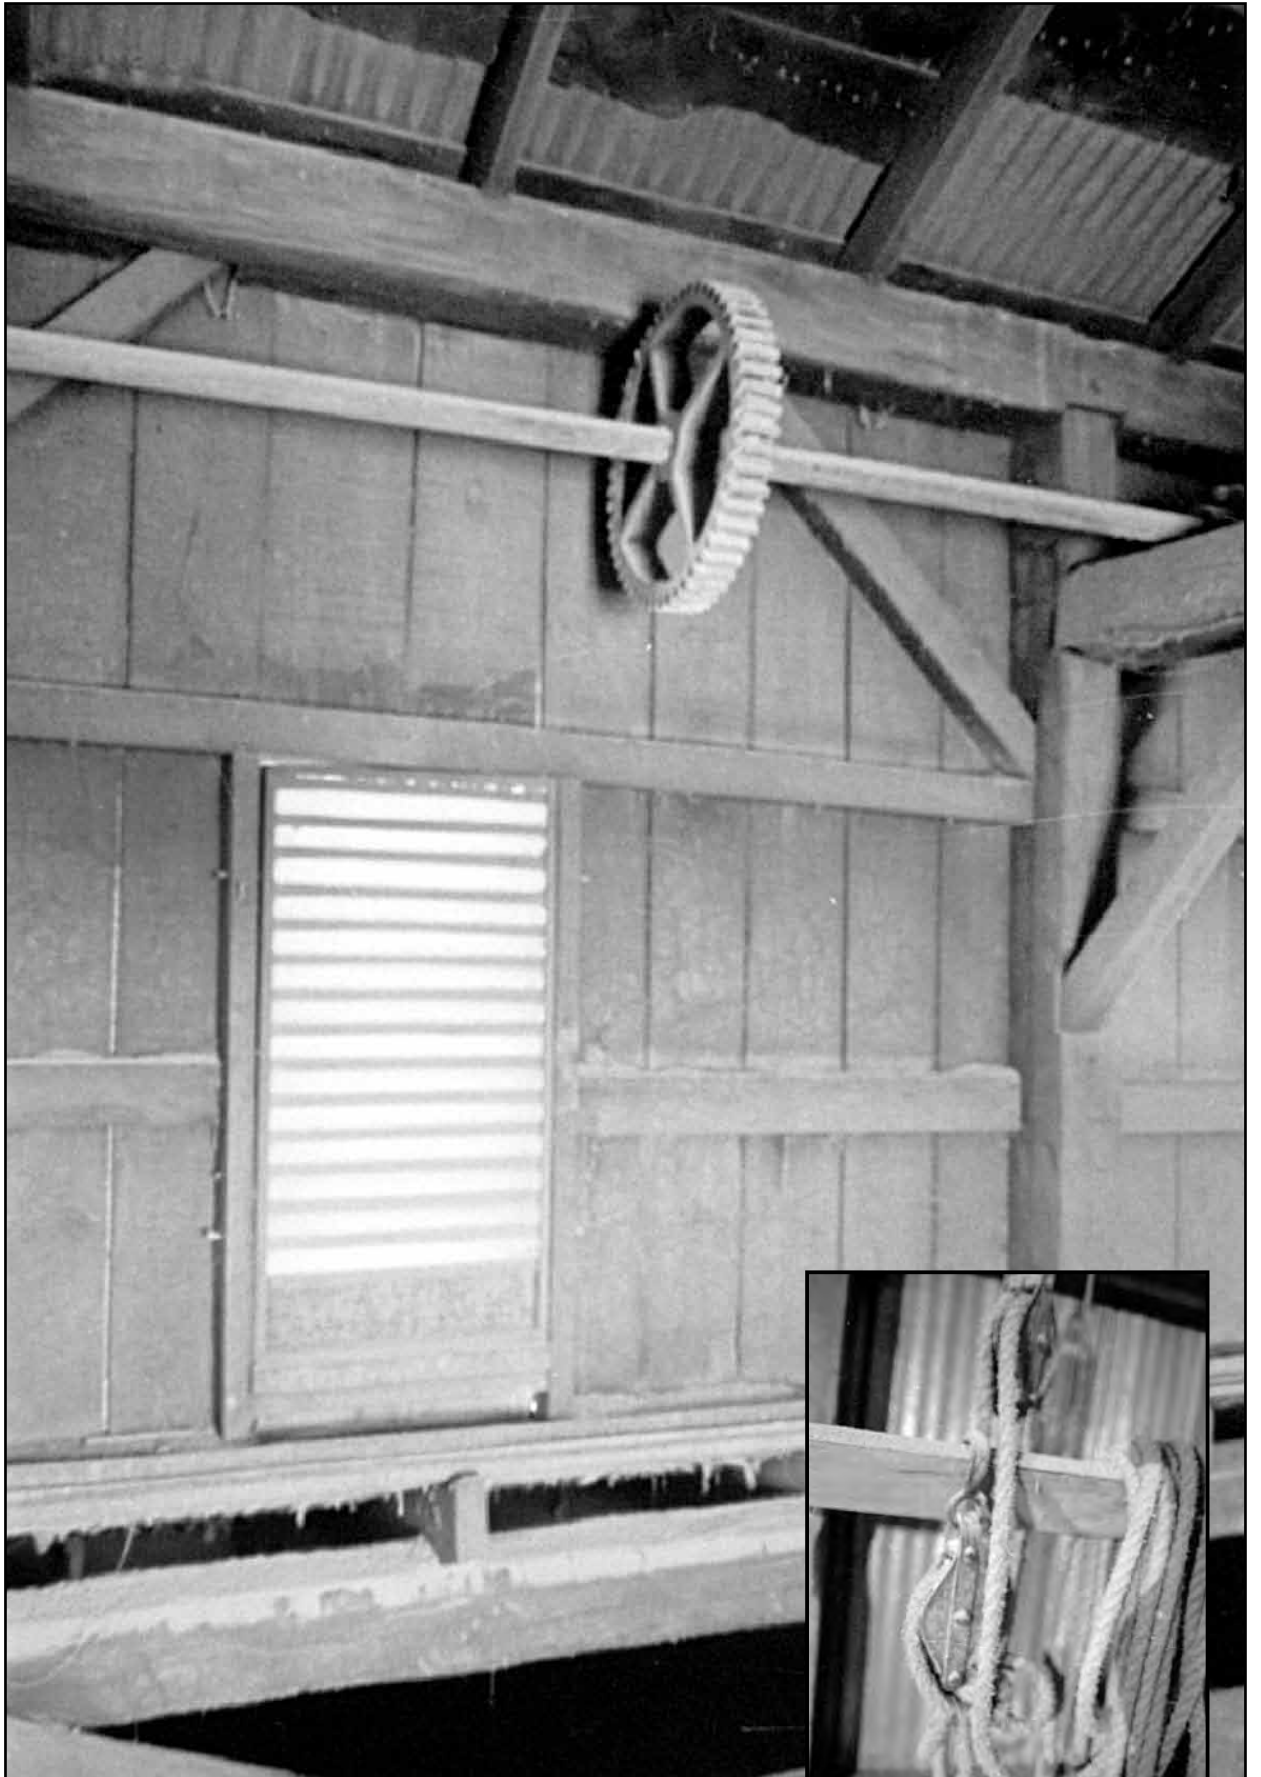
A cogged wheel high on a wall in the cupola and pulleys and rope hanging from the beams.

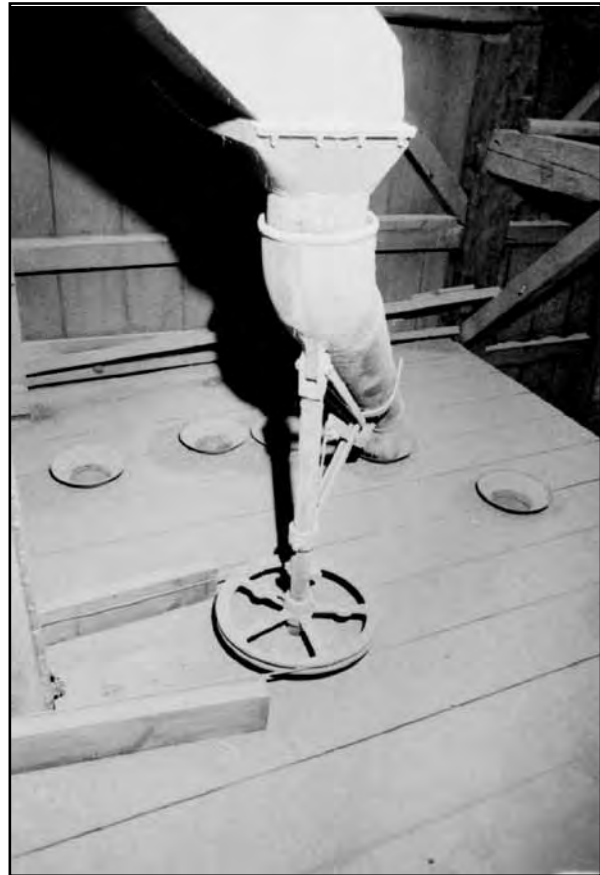
Upper right: One of the two turnheads in the cupola, controlled by a dial on the main floor, for directing grain to the proper bins.

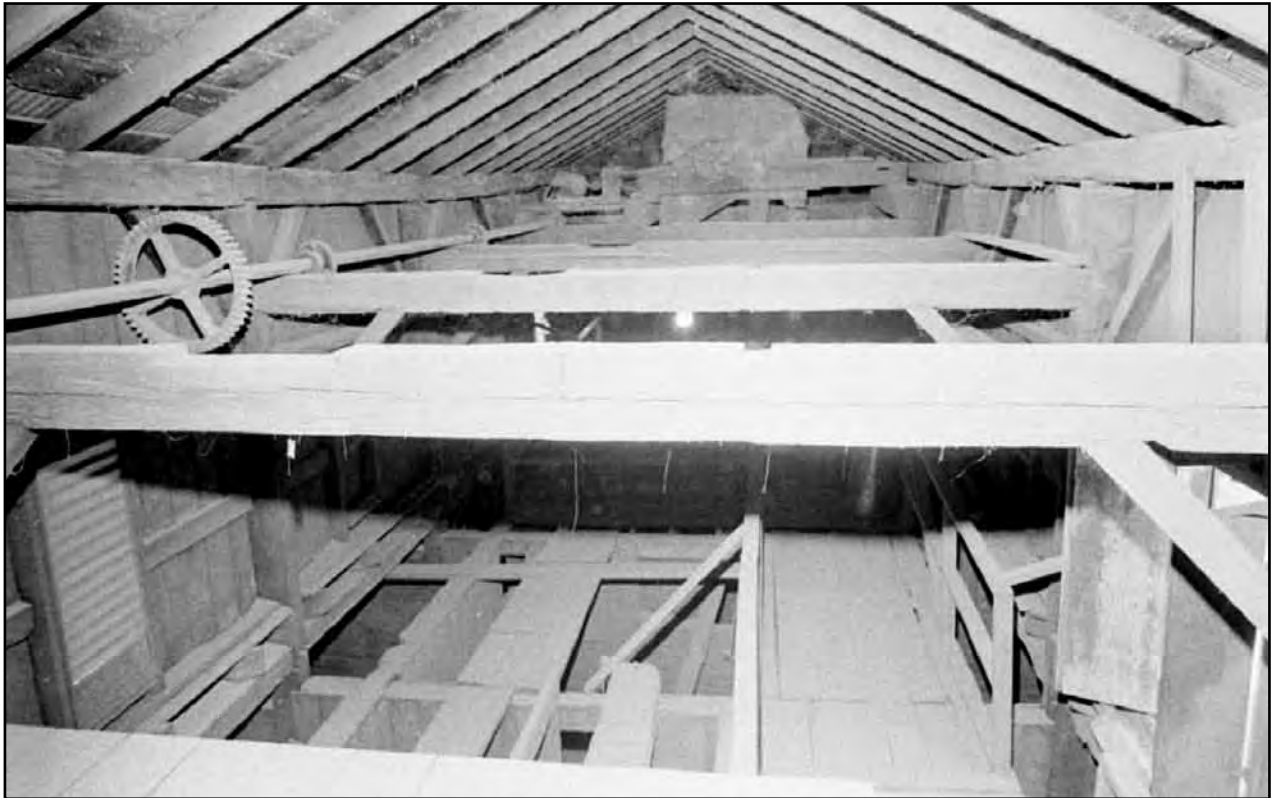
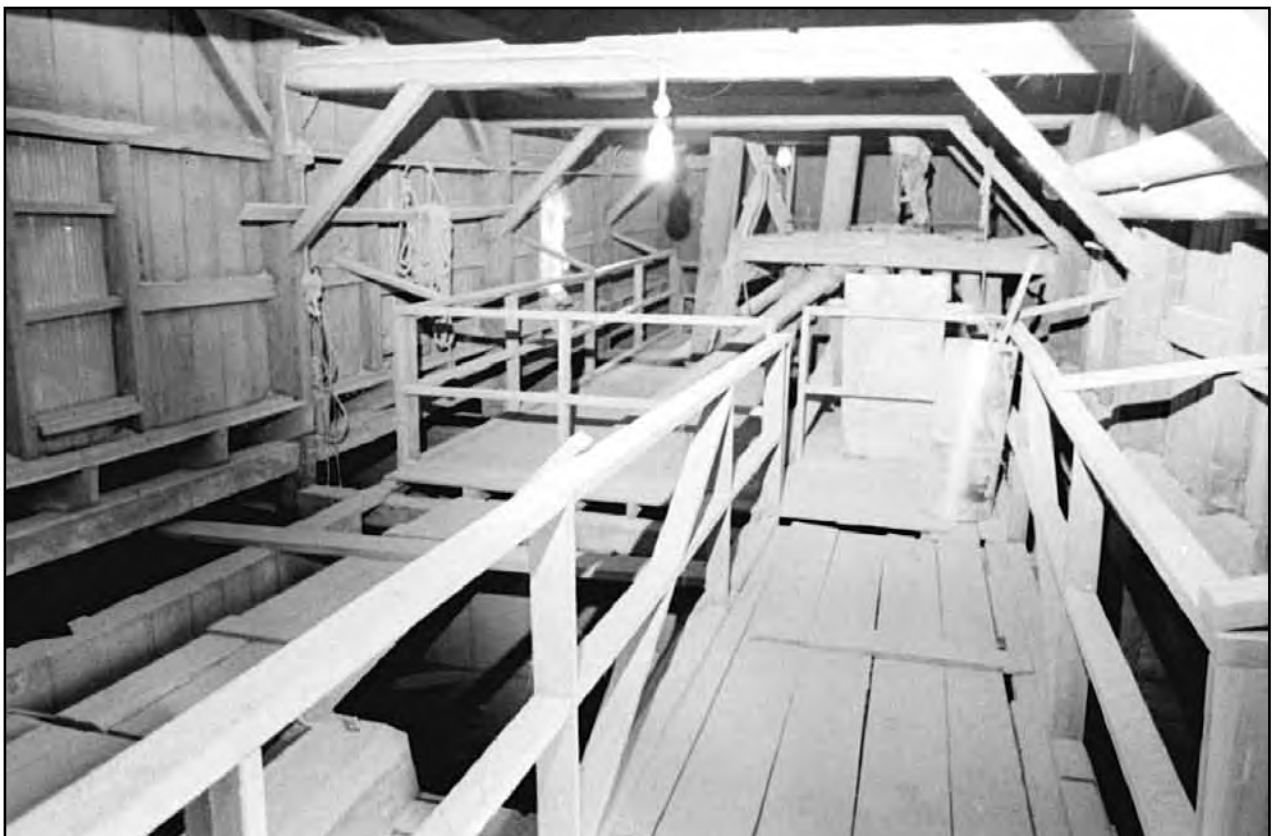
The headhouse (cupola) at the top of the elevator stretched over a series of about 18 grain bins, which were 30 feet deep. Upper picture shows an elevated view looking down through the beams to the "bin deck" walkways which are the same level as the top of the bins. Bottom picture shows the walkways and handrails in the "bin deck" which allowed access to equipment located over top of the bins.

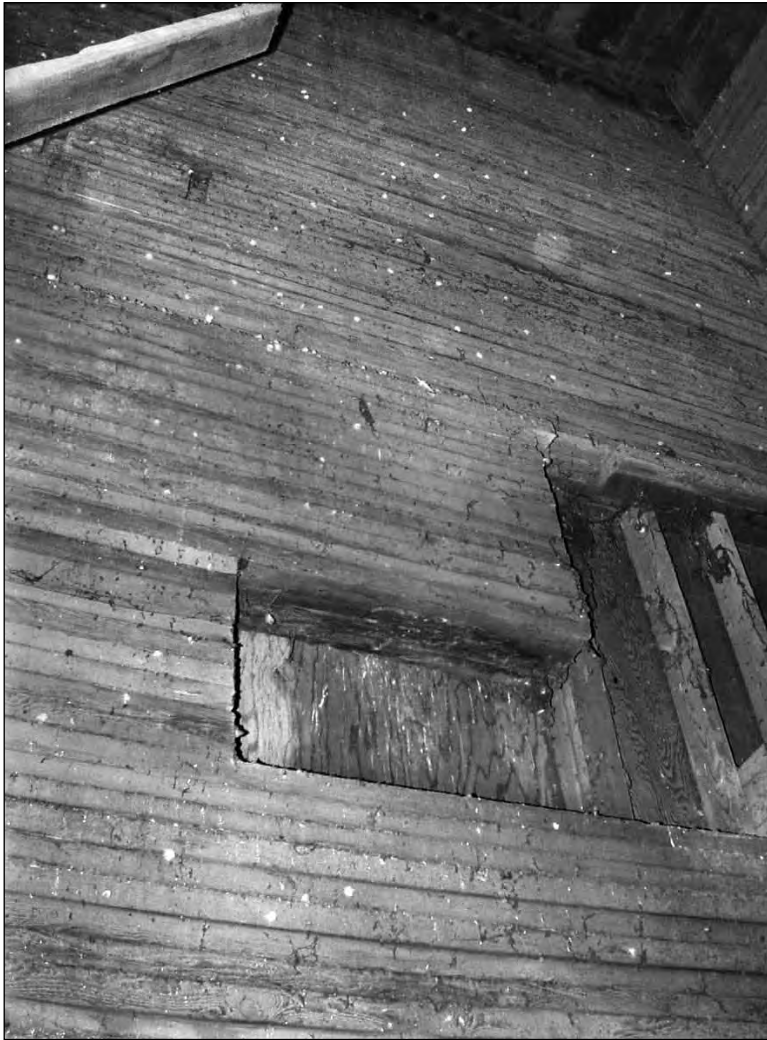
The walls are formed of solid pine boards, 2" x 10" in size and are spiked together to form a laminated wall. At left, is a cross section of the boards, showing the full eight inch width of the boards.

There are four sets of stairs rising almost 55' to get to the top of the elevator. The walls are formed of solid pine boards, 2" x 10" and 2"x8", which are all spiked together to form a heavy laminated wall.

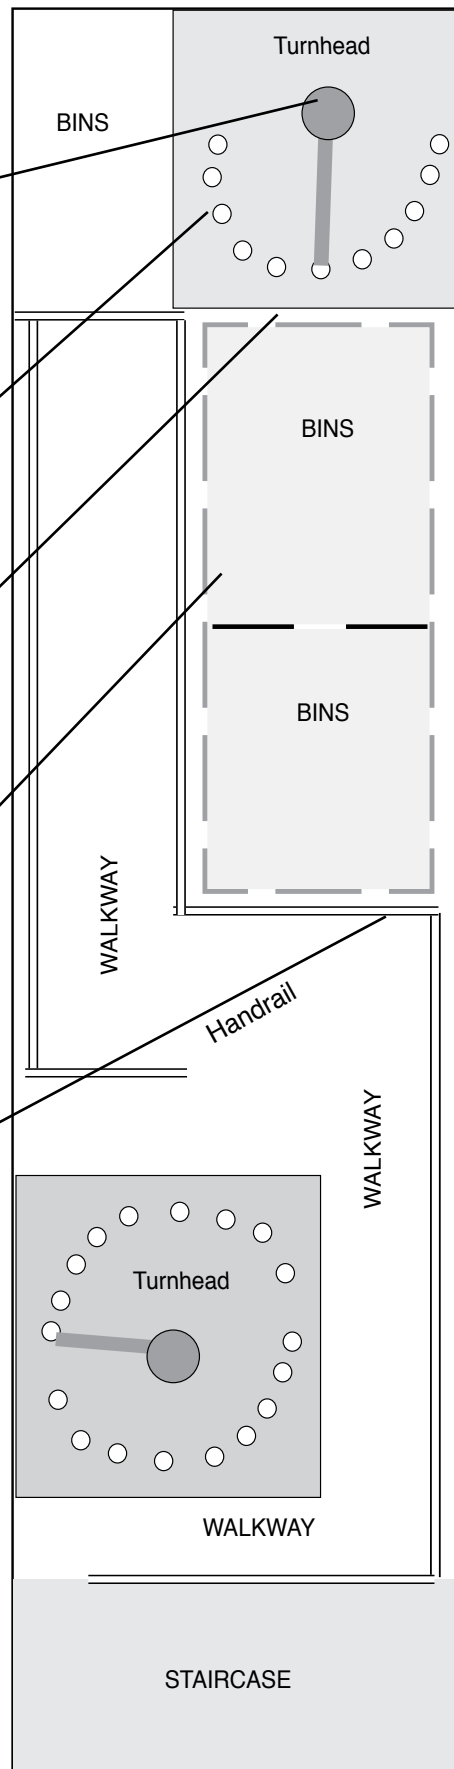
View from the Cupola looking south along the walkway. Grain bins on right or handrail all along the east side. Elevated platform (approx. 11' x 12' ) at far end (south) holds the equipment necessary to distribute grain arriving from main floor into the proper bins.

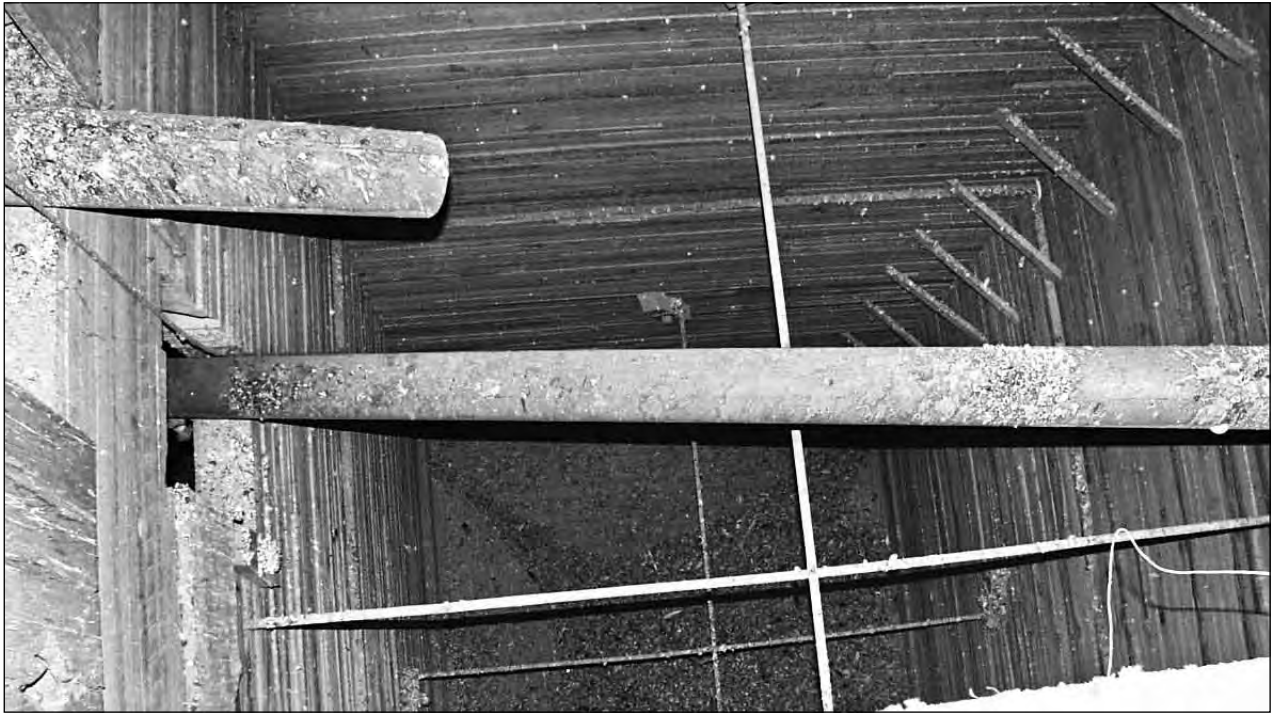
Above, the end of one distribution pipe sits over a bin in the Port Perry elevator, while the lower pipe passes through the bin directing grain to a different destination further along the building. The bins range in size, but this large one is about 10' x 17' x 30' deep.

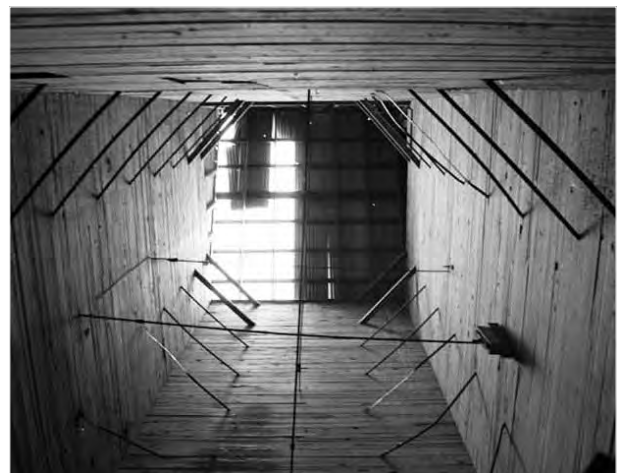
Right: This picture of a grain bin from the Pullman, WA grain elevator as it was being dismantled, shows that the construction style was very similar, if not the same as the Port Perry elevator.

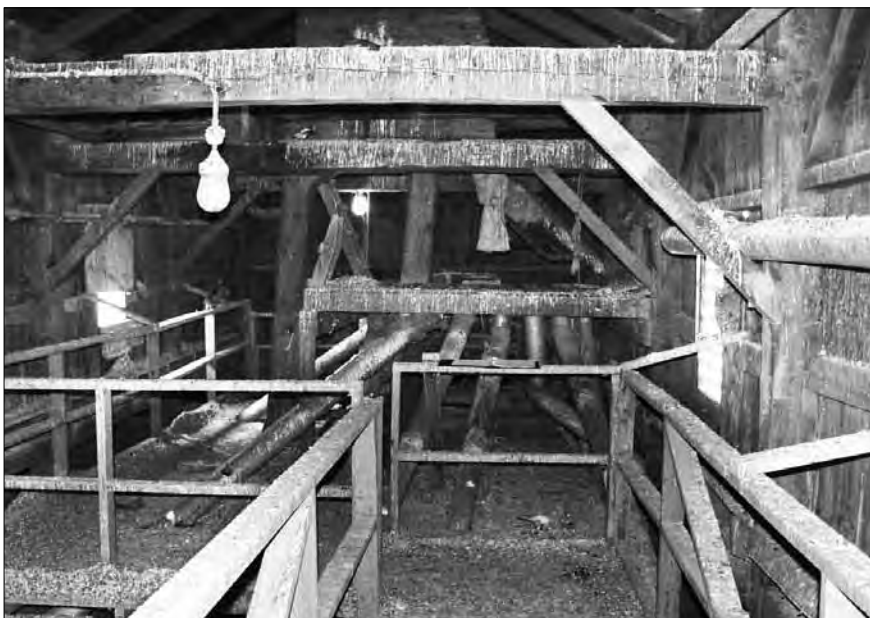
Left, In the cupola, looking north, the raised (turnhead) platform is visible at the far end of the cupola with metal pipes coming from under the turnhead and heading off to one of the more than 20 bins in the elevator.

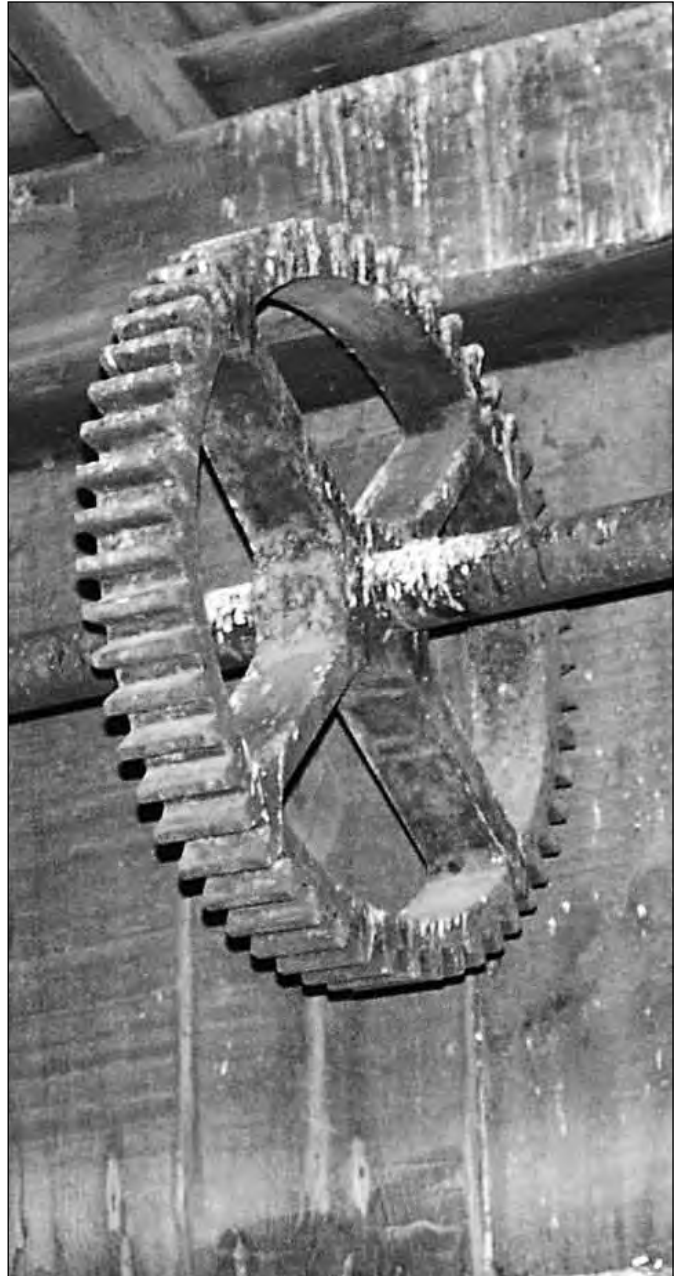
This large wooden pulley, left, and cogged wheel, above, have been standing idle for almost a century. They were used during the early days of the elevators operation to bring grain to the top of the elevator.

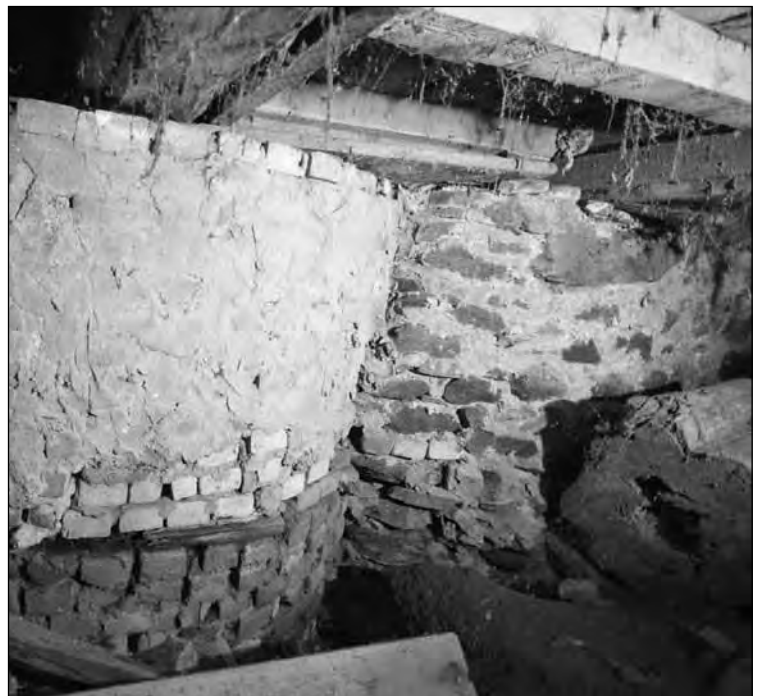
The foundation of the elevator was originally stone, but appears to have been repaired a number of times with brick and cement patching.
